HRSG tube cleaning

Successful case study. A Caribbean plant increase its benefit thanks to the its HRSG tube cleaning

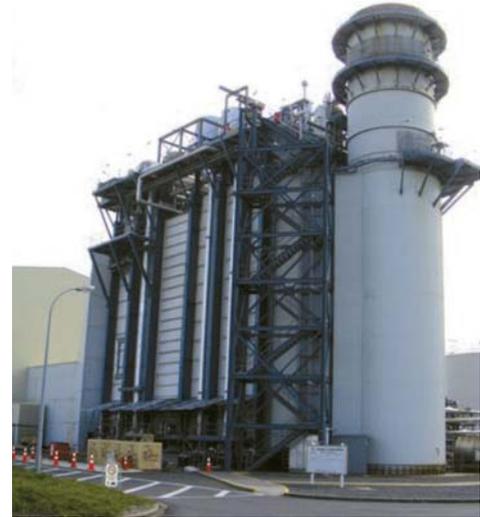
Precision Iceblast HRGS tube cleaning system consists in blasting dry ice at very high pressure (350 psi). The dry ice does a great job cleaning the first couple rows of tubes. Beyond that it is just simply the force of air pushing the debris through the tubes.

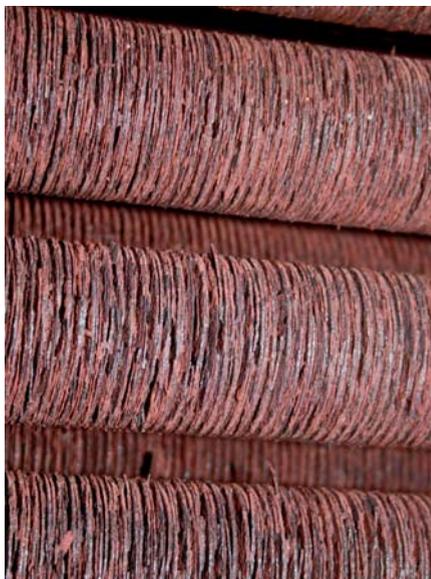
These spreader bars are placed in every fourth tube on each face. Spreading the face every four tubes gives us the ability to clean two tubes to the left of the

alignment bar and two tubes to the right of the alignment bar. We then move to the next alignment bar cleaning two tubes to the left again and two tubes to the right. This process allows us to open up lanes and have direct access to the face of tubes that are four to five rows deep.

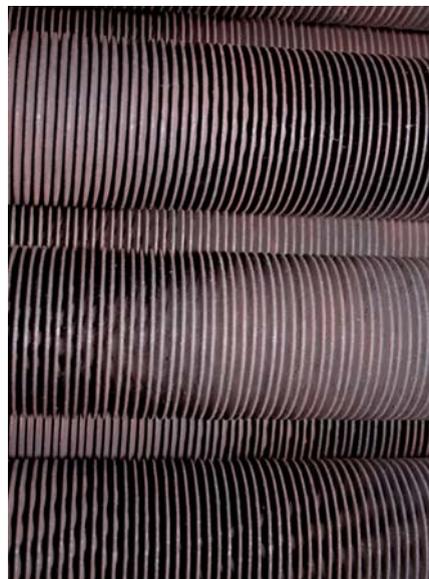
Before and after pictures of the cleaning, using tube spreading process

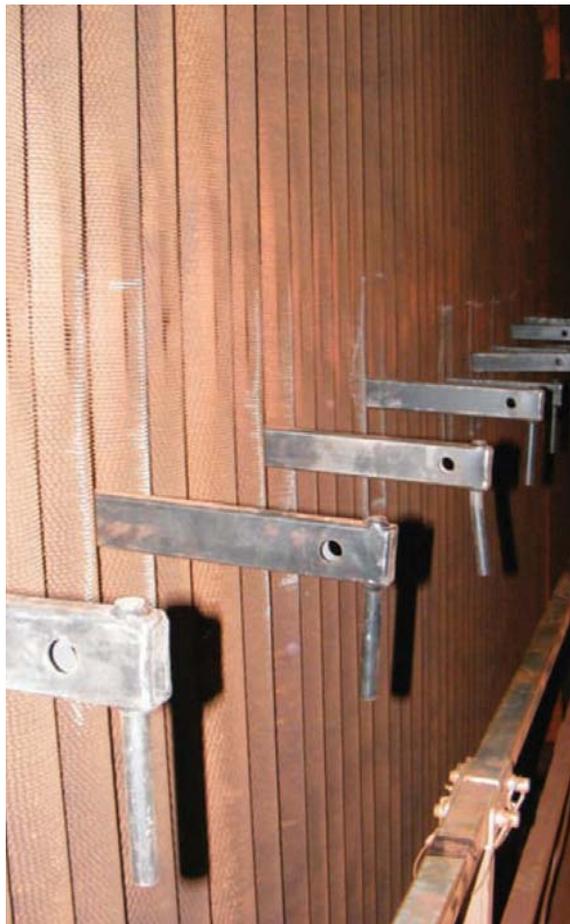
Tube spreading

Penal 10 Power Station before and after cleaning

Day six: Precision Iceblast setup to tube spread the first face (face #1). After

demonstrating for the plant the procedure the crew spent the day cleaning this one face. Once cleaning was completed the Penal Power and Precision Iceblast inspected the faces to insure cleanliness and took after pictures of the boiler tubes.

Day seven, eight and nine: Precision Iceblast repeats this operation during the forthcoming three days in order to clean the faces #2, #3,#4, #5 & #6). The last day all areas were blown down. After the cleaning and blow down was completed the crew packed up all blasting and equipment and set up equipment to clean out the unit the next morning.
