Clean fouled HRSG tubes, Increase Reliability

By Douglas Stvanovck Coutinho, Precision Iceblast Corporation

Plant Information

2x GAS TURBINE	GE 7FA.04 - 168,872 MW
1x STEAM TURBINE	GE D11A - 184,091 MW
2x HRSG BOILER	VOGT / 2012
START DATE: 05/17/2019	END DATE: 05/28/2019

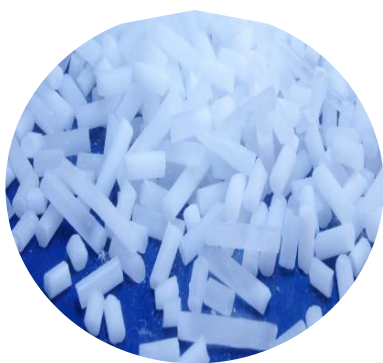
Cleaning with dry grain
CO₂ pellets
(rice grain 3mm)

Blast Gun

CO₂ Particle
(Size: 3 mm)

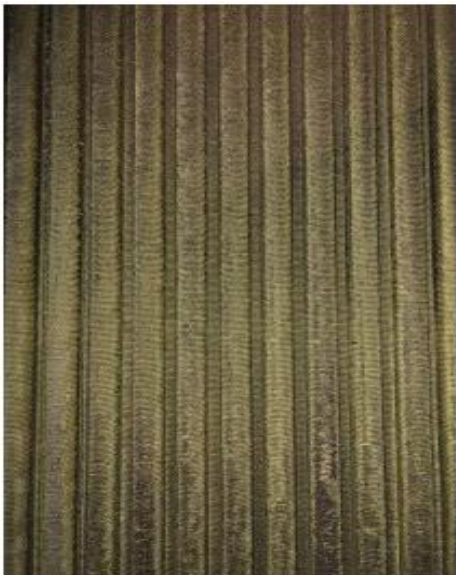
High concentration of sulfur deposits on the external heating surface of the fin tubes of the HRSG # 51 and HRSG # 52 boiler preheating module. Oxidation and partial corrosion principle.

Image of HRSG#51 water preheater tubes with sulfur deposits.

Cleaning the boiler water preheating module HRSG # 51 and HRSG # 52. Each module with a total square area of 2207 ft².

The cleaning process was carried out with 3mm pellets of dry ice (CO₂), used as an impact agent against the outer walls of the encrusted tubes accelerated by ultra-high pressure compressed air (350PSI / 24bar). The entire process was also carried out with blasting equipment and deep cleaning devices developed and patented by Precision Iceblast itself

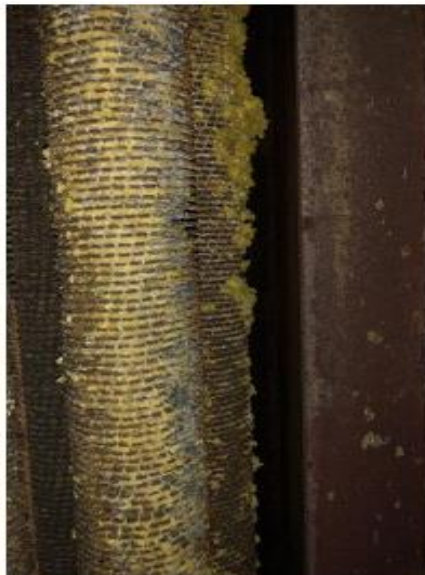
Image of HRSG#52 water preheater tubes with sulfur deposits.

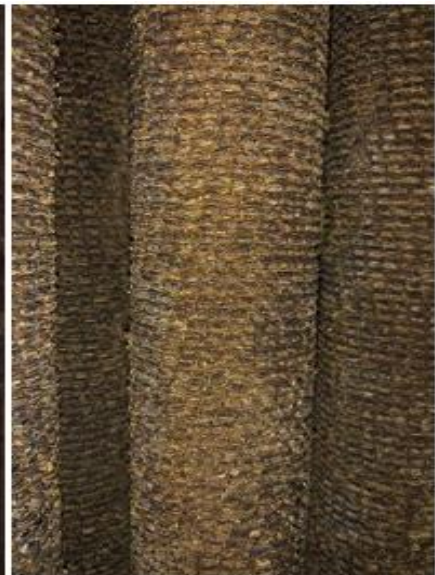
Images of HRSG#51 water preheater tubes with oxidation and corrosion principle.

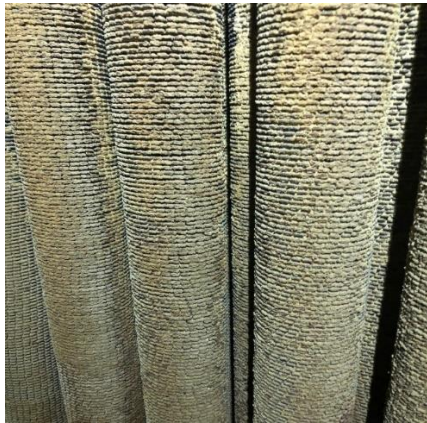
Tubes Before Cleaning

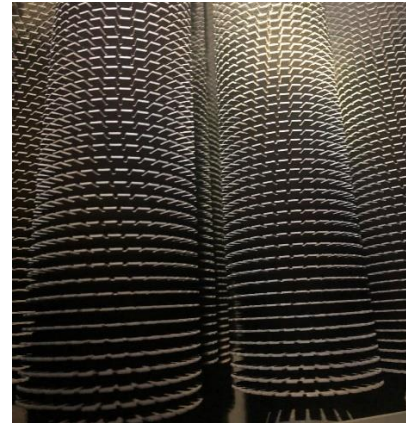
Tubes After Cleaning

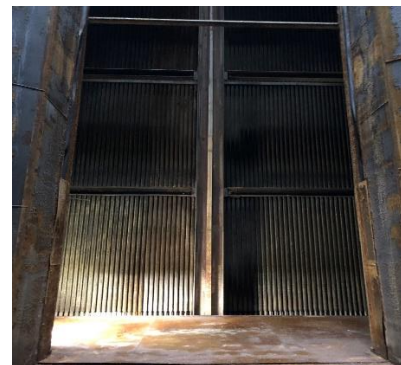
Boiler / stack floor
completely clean

Cleaning started at the top of the face between (module 4 and stack) of HRSG # 51, blasting from top to bottom. Once completed, the same procedure was applied to the face between (modules 3 and 4) of HRSG # 51. After cleaning both sides of module 4 of the HRSG # 51 boiler, the 2 scaffolding towers were uninstalled, and all dirt was removed from the boiler floor.
