COMBINED CYCLE POWER PLANT
 Post Cleaning Summary

USA
 West

BACKGROUND:

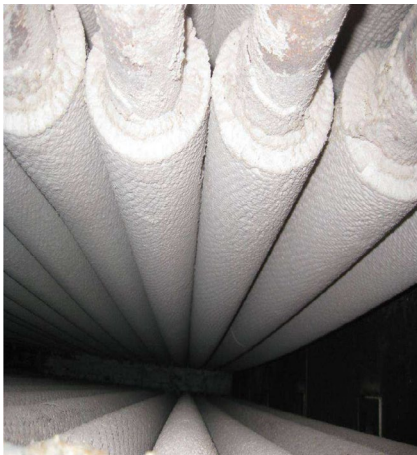
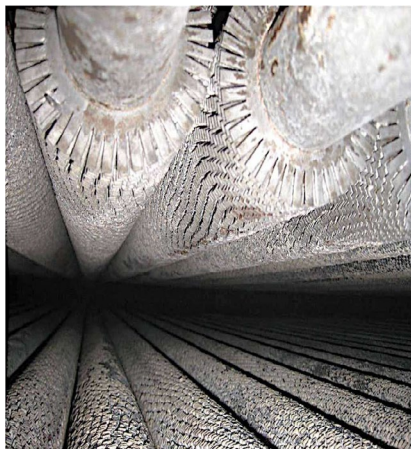
CLEANING RESULTS:

Debris Removed

- PIC Deep Cleaning removed approximately 4x the amount of debris than Conventional Cleaning
- This plant has very quick debris build up due to the ammonia injection grid.

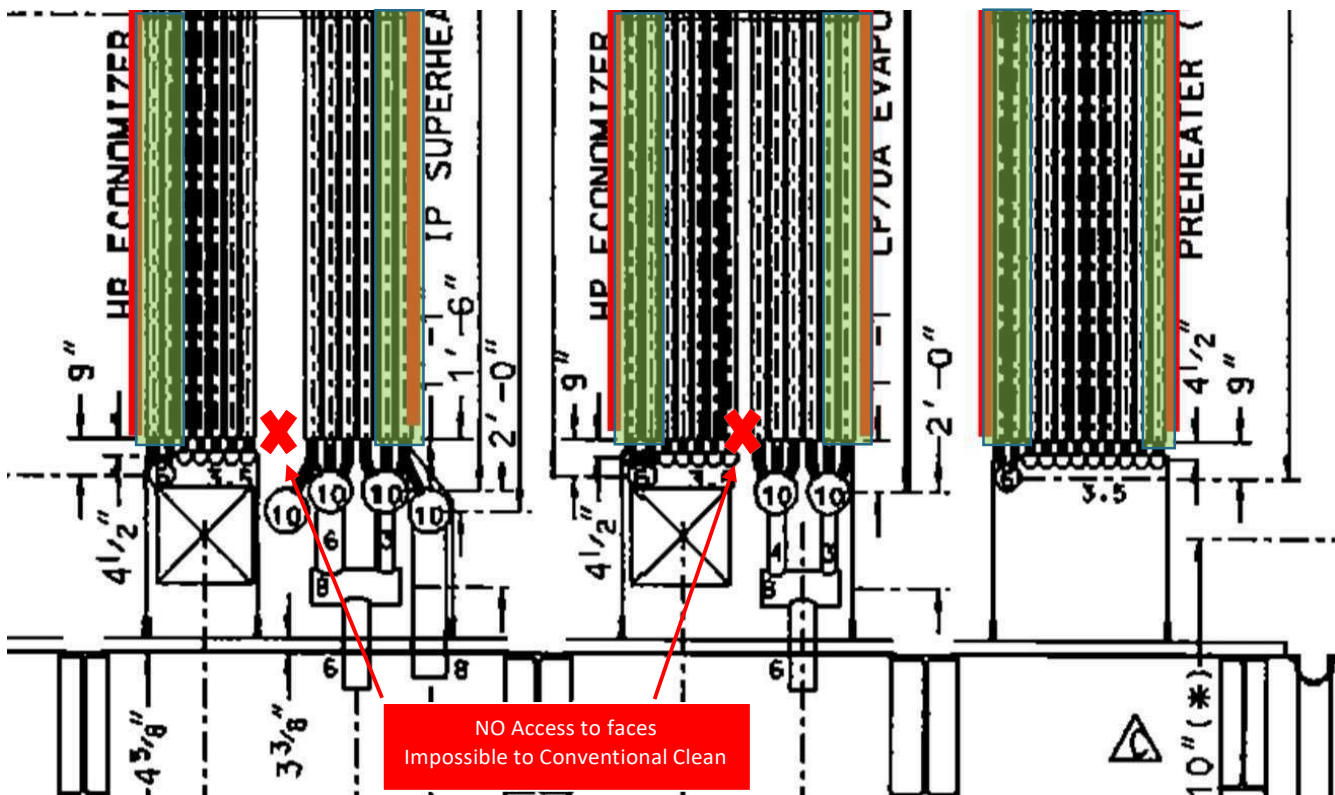
PIC Conventional Cleaning (24 Bar / 350 PSI):

Green areas represent tube surfaces cleaned

Conventional cleaning only cleans the surface of the first rows and lower than 24 Bar pressure cleans even less

- “partial” or “surface” cleaning reached debris approximately 2 tubes deep
- This type of cleaning only work effectively for small modules (4-6 tubes) at 24 Bar (350 PSI)
- The amount of cleaning with this method was only 20-25 % of the surface area
- The largest module was 14 rows deep
- Spaces between the modules made it impossible to surface clean where there was no access

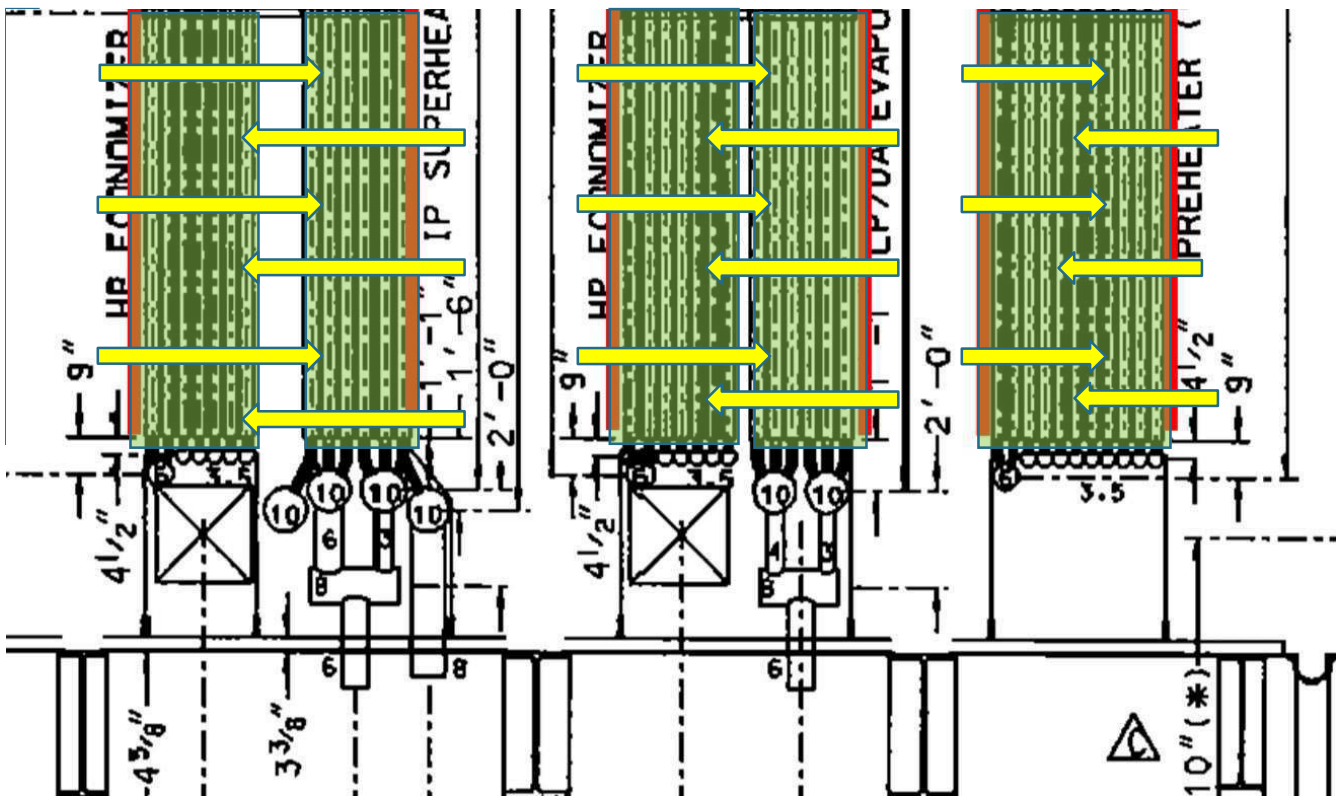
PIC Deep Cleaning (24 Bar / 350 PSI)

PIC Deep Cleaning tools reach through modules to clean all faces and overlap to fully cleaning

- PIC Deep Cleaning reached debris throughout the modules in all directions
- The amount of cleaning with this method cleaned 95 % of the surface area
- The largest module was 14 rows deep
- Spaces between were reached with special tools and all faces were cleaned even though there was limited access

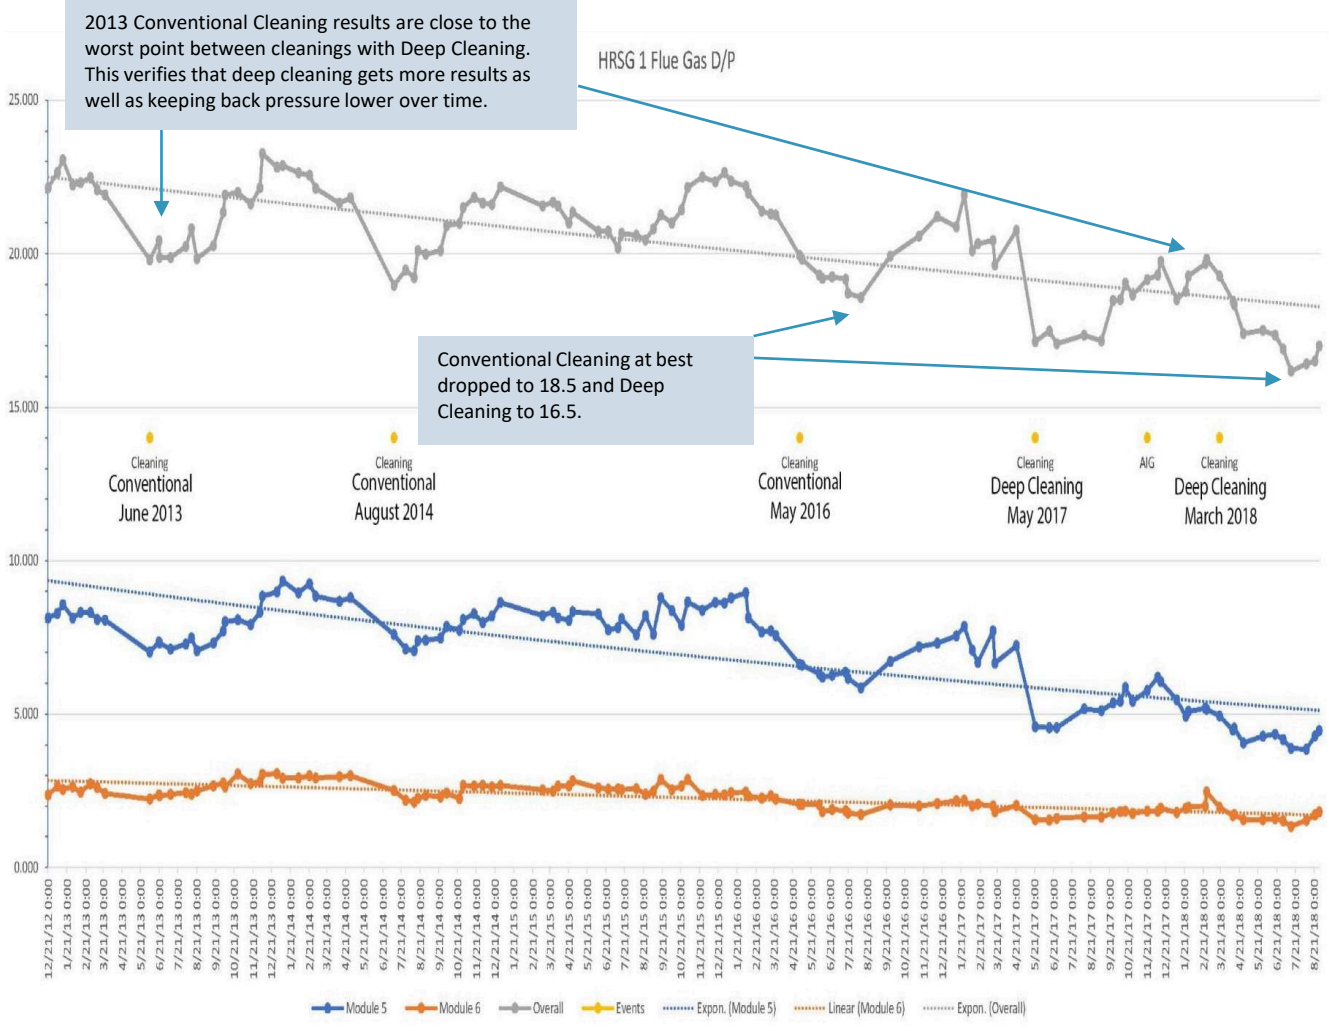
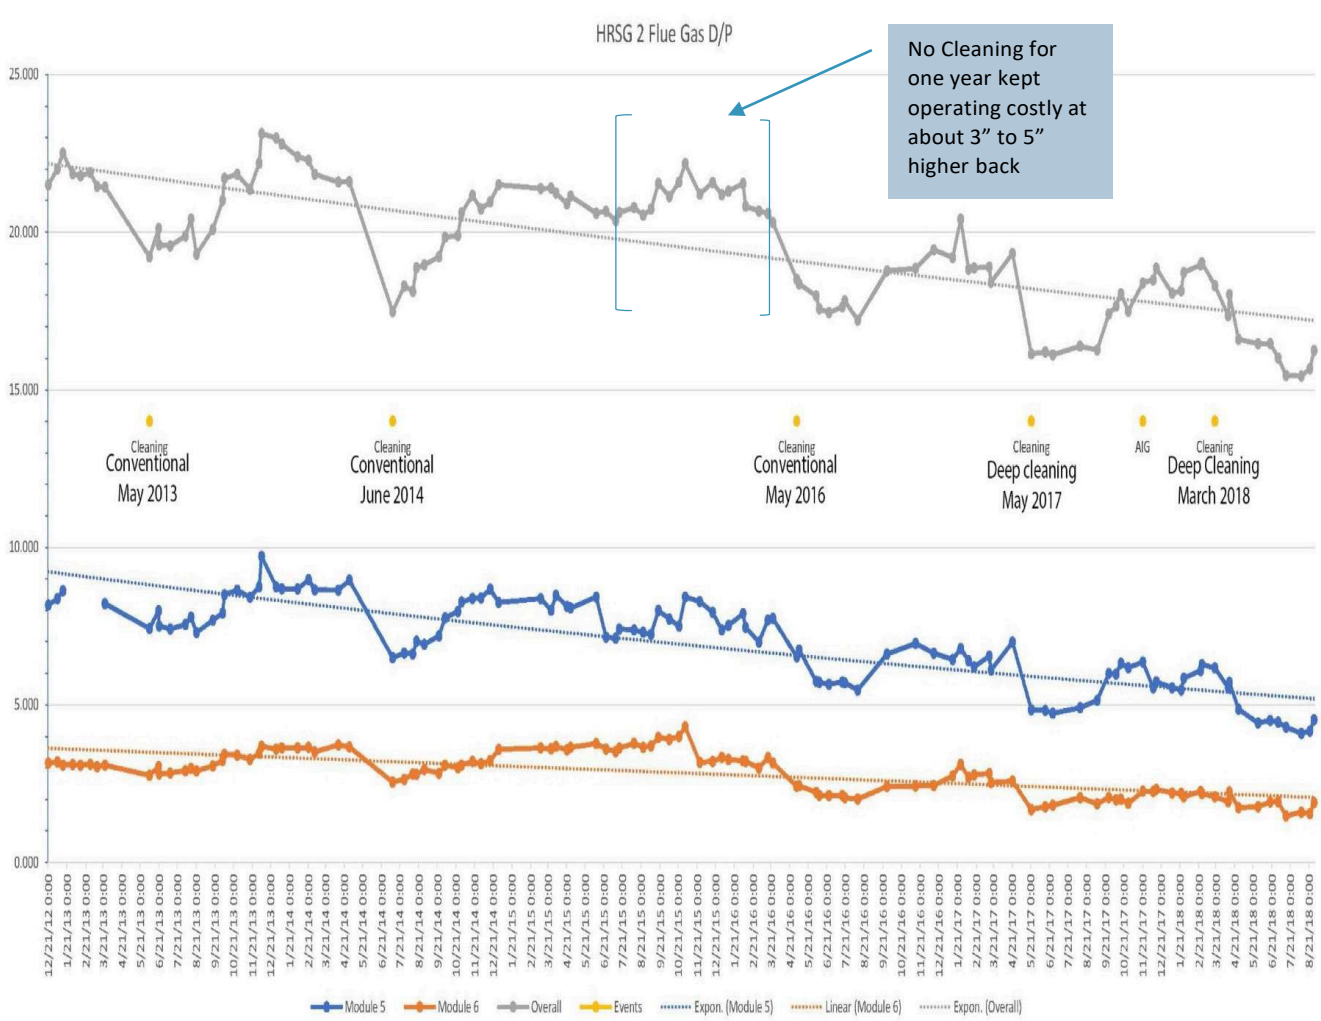
GT Back Pressure (Differential Pressure) over 5 Years

Both HRSGs cleaned showed similar results that HRSG cleaning is beneficial as soon as the HRSG is fouled. The Data also shows the additional benefits of PIC Deep Cleaning.

- PIC Deep Cleaning annually was a better investment for the plant than Conventional Cleaning
- This plant can be used as an example for any plant that needs to be cleaned and is deciding on using Conventional Cleaning or PIC Deep Cleaning
- The cost of additional fuel and loss output from 2013 to 2017 was much greater than the additional cost of PIC Deep Cleaning.
